Rep No. ET201812015

Test Report

Name of Sample:	INDUSTRIAL TABLET
Model No.:	P80
Client:	SHENZHEN CHAINWAY INFORMATION TECHNOLOGY
	CO.,LTD.
Manufacturer:	SHENZHEN CHAINWAY INFORMATION TECHNOLOGY
	CO.,LTD.
Test Sort:	Commission Test
Test Item:	IP65

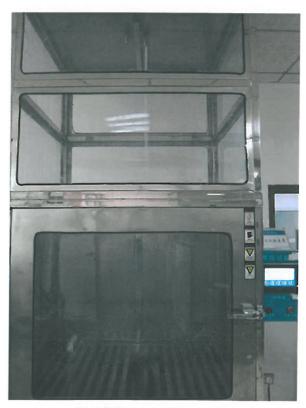
IPX5(ET20181228001-2/3)

(1) Place the sample into the test chamber, the test condition is as below:

Test means: Spraying the enclosure from all practicable directions with a stream of water from a standard test nozzle as specified in test standard.

Internal diameter of the nozzle: 6.3 mm

Delivery rate: 12.5 L/min ±5%

Distance from nozzle to enclosure surface: between 2.5 m and 3 m

Test duration: 3 minutes

Check Item Sample No.:	Visual check
ET20181228001-1/3	After the IP6X test, No trace of dust inside sample The 1.0mm test stick can not enter the gap of the sample
ET20181228001-2/3	After the IPX5 test, No ingress of water was found inside sample
